Manhole Inspection Summary

Manhole # S09GG2017MH

Location Address: **6210 GREEN MEADOW PKWY** Cross Street: **EDENVALE RD**

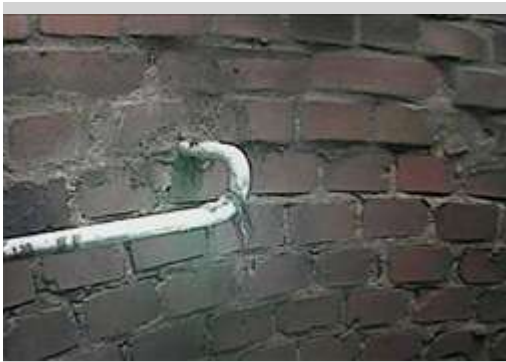
Comments **I3 pipe picture and the evidence of surcharge picture both indicate evidence of infiltration through the mortar of the barrel wall.**

Barrel Material: **Brick** ☐ Parged
Shape: **Circular** Diameter: **48** (in.) Length: (in.)
Condition: ☒ Sound ☐ Cracked ☐ Root Intrusion ☐ Loose Brick ☐ Deteriorated
Infiltration: ☐ None ☐ Joint ☐ Cracks ☒ **Mortar** ☐ Roots ☐ Wall

Surcharge ☒ **Evidence Of Surcharge** Depth: **4** (ft.) ☐ Active Surcharge Present

evidence of surcharge

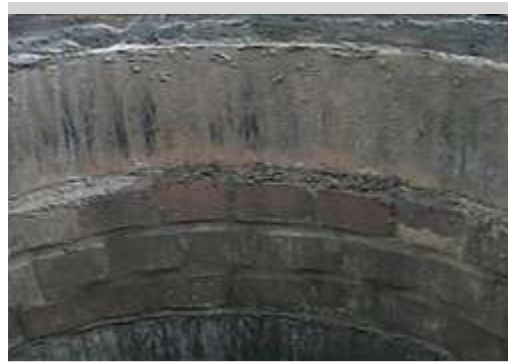
Defect

Frame leak

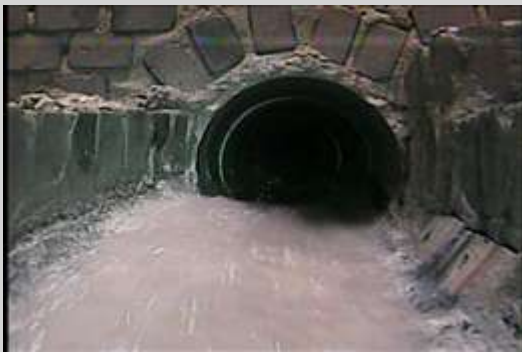
12 in. Circular Gravity Sewer Pipe Out @ 12 O'Clock

Pipe Material: **Clay** ☐ Pipe Lined

Invert Depth: **10.14** (ft.) Flow Characteristics: **Fast**

Infiltration: **None** Pipe Seal Cond: **Sound**

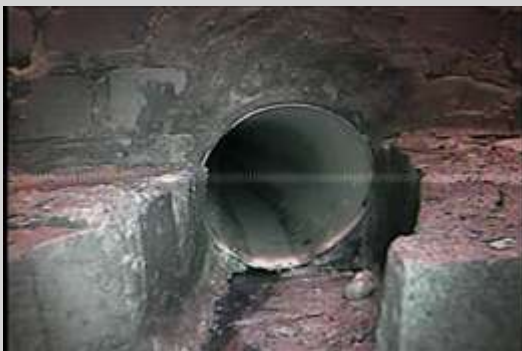
6 in. Circular Gravity Sewer Pipe In @ 3 O'Clock

Pipe Material: **PVC** ☐ Pipe Lined

Invert Depth: **9.24** (ft.) Flow Characteristics: **None**

Infiltration: **None** Pipe Seal Cond: **Sound**

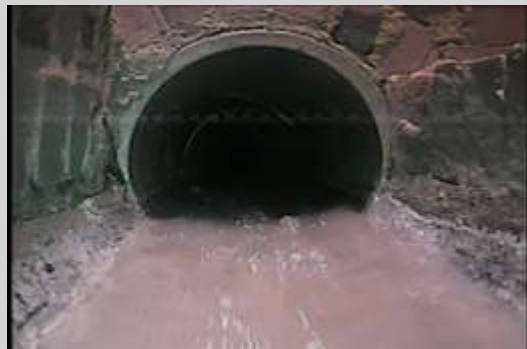
12 in. Circular Gravity Sewer

Pipe Material: **Clay**

Infiltration: **None**

Pipe Seal Cond: **Sound**
